Obsolescence and the end-of-life phase of buildings

Understanding the underlying processes

André Thomsen
ERES Conference 2017, Delft

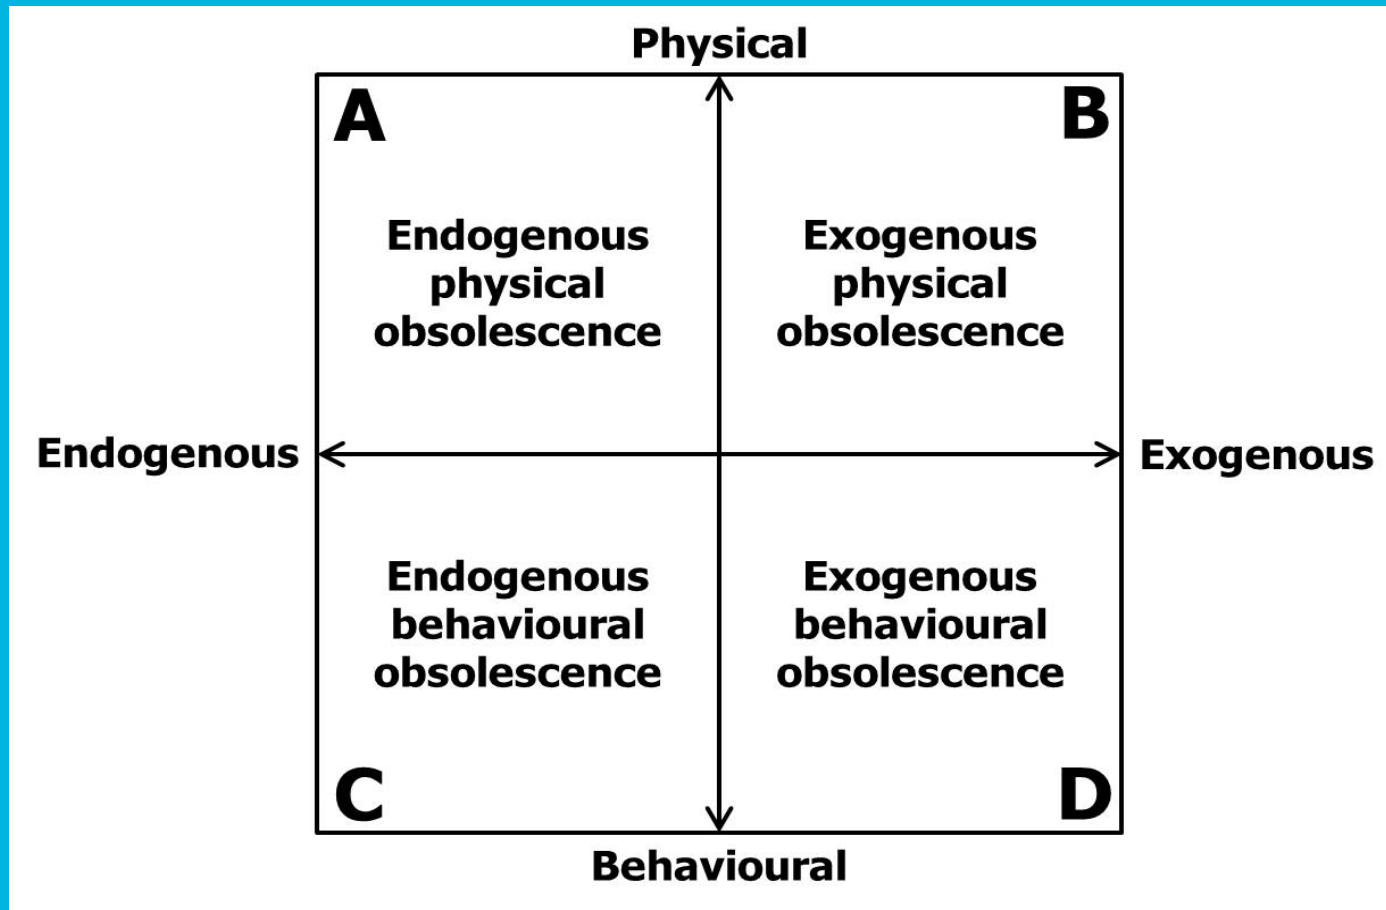
Types of obsolescence (revised)
